Thermally Broken Roof Hatch

Introducing the Thermally Broken Roof Hatch, the New Standard in Energy Efficiency

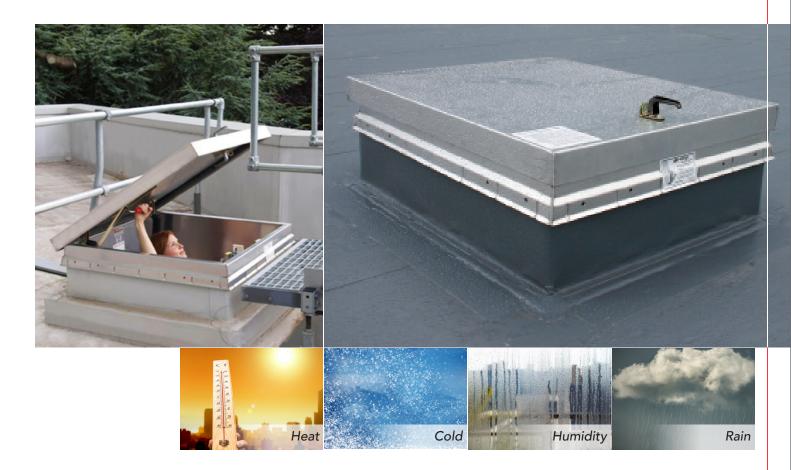
Thermally broken roof hatches feature a frame and cover design that minimizes heat transfer between interior and exterior metal surfaces. The result is a product that resists harmful condensation and provides superior energy efficiency.

- Thermally broken design
- Aluminum construction
- R-20+ insulation in the cover & curb
- Special gasketing for wind resistance

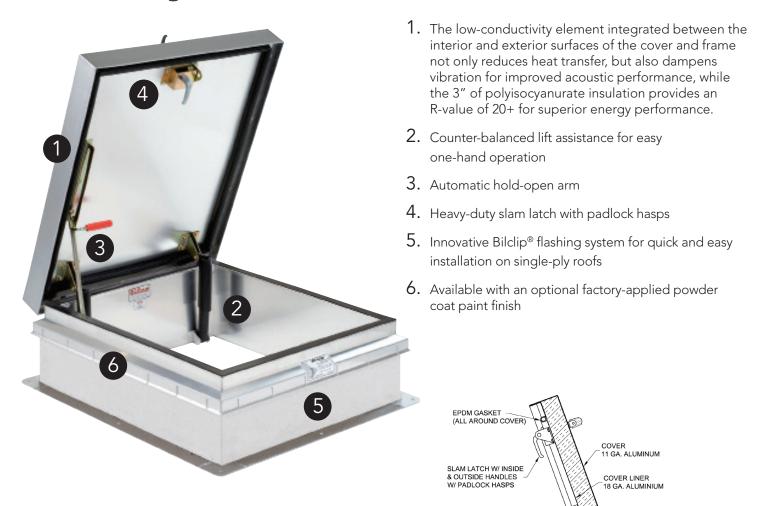
ARM GUIDE BRACKET

Type S-50TB and E-50TB shown. All other models open to 90°.

3" [76MM] POLYISOCYANURATE COVER INSULATION
